CLOSE CALL SHAFT SINKING ACCIDENT

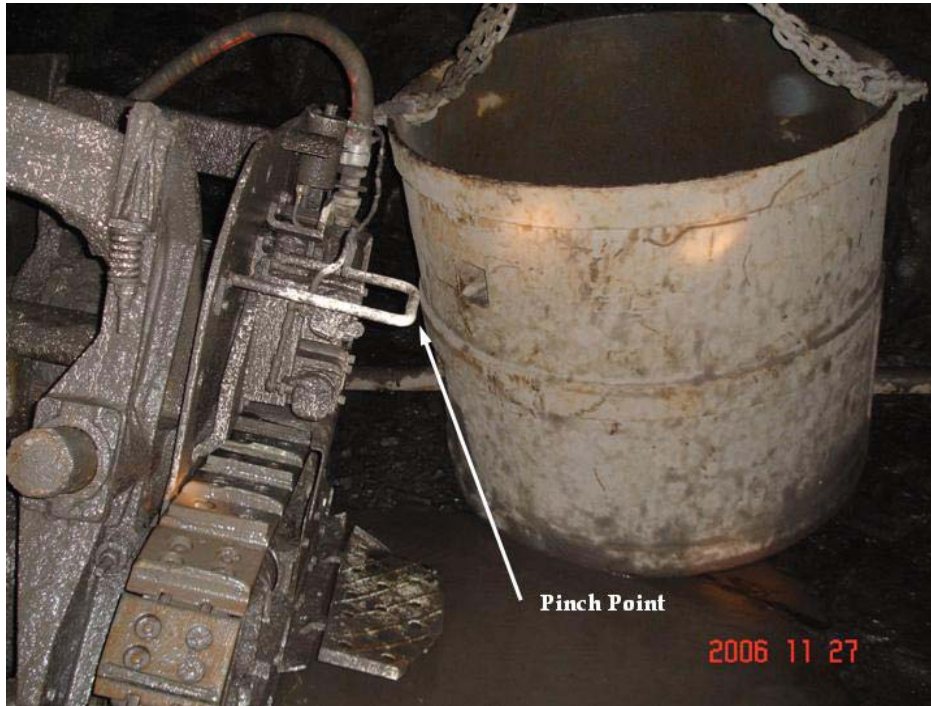
On November 27, 2006, during shaft sinking operations, the operator of the Eimco track mounted mucking machine was cleaning loose material at the 297-ft level of the shaft. While loading the material, he inadvertently placed himself in a pinch point, between the mucking machine and the shaft bucket. He suffered injuries to his lower extremities, and was held for observation at a local hospital for two days, and then released.

1. Maintain adequate clearance between equipment, both stationary and mobile, and work from the safest location possible.
2. Always look in the direction of movement and exercise caution in close work areas.
3. Operate equipment so that control is maintained.
4. Develop processes, involving all miners, designed to proactively identify and eliminate hazards and unacceptable risks.
